Military & Aerospace/Avionics COTS Conference

August 22-25, 2000

Commercial Off-The-Shelf (COTS) Program

ESD LATENCY - Reliability Investigation & Analysis

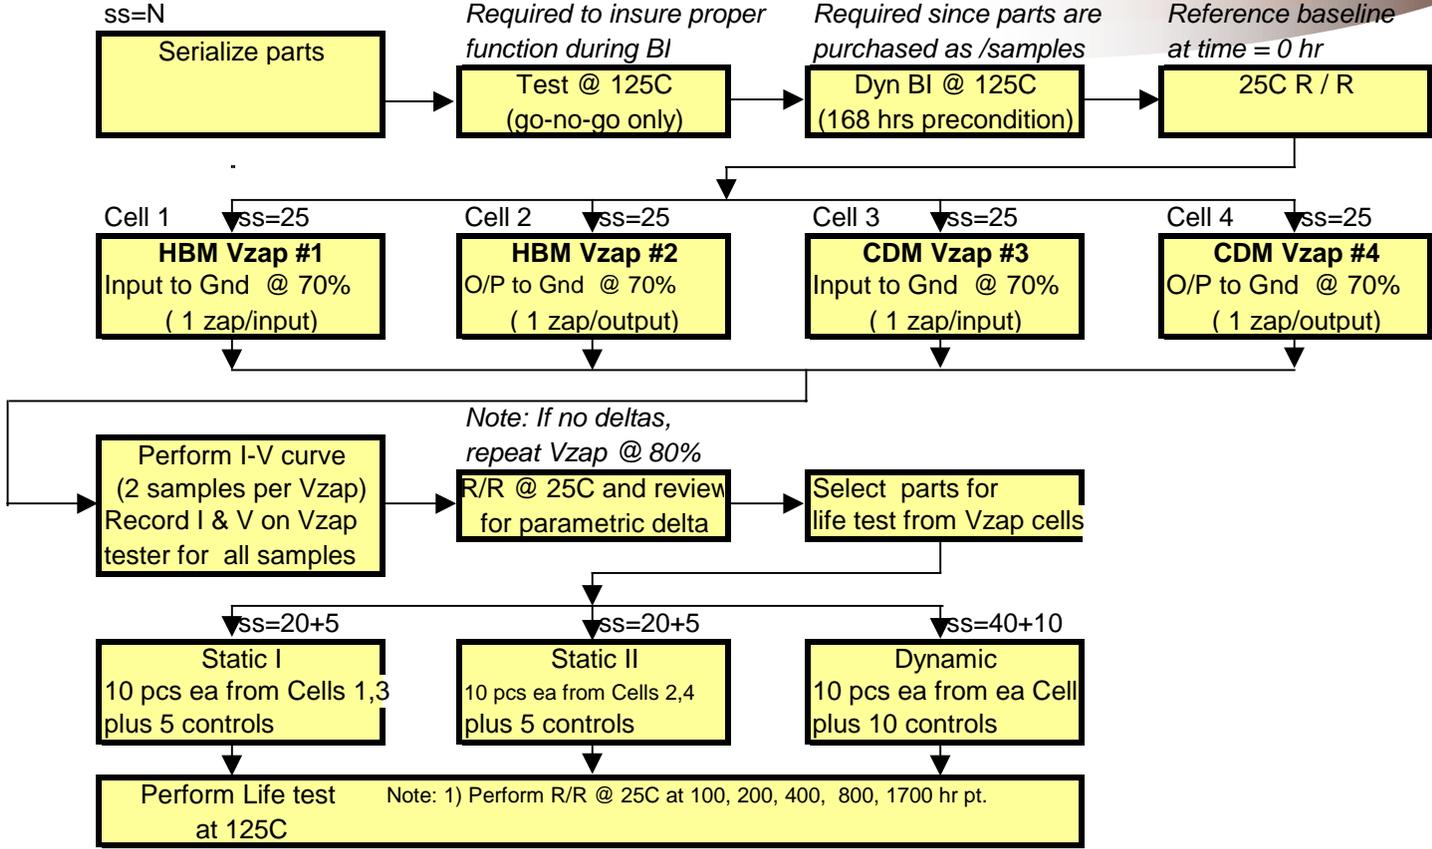
FLOW:

EXPERIMENTAL DESIGN

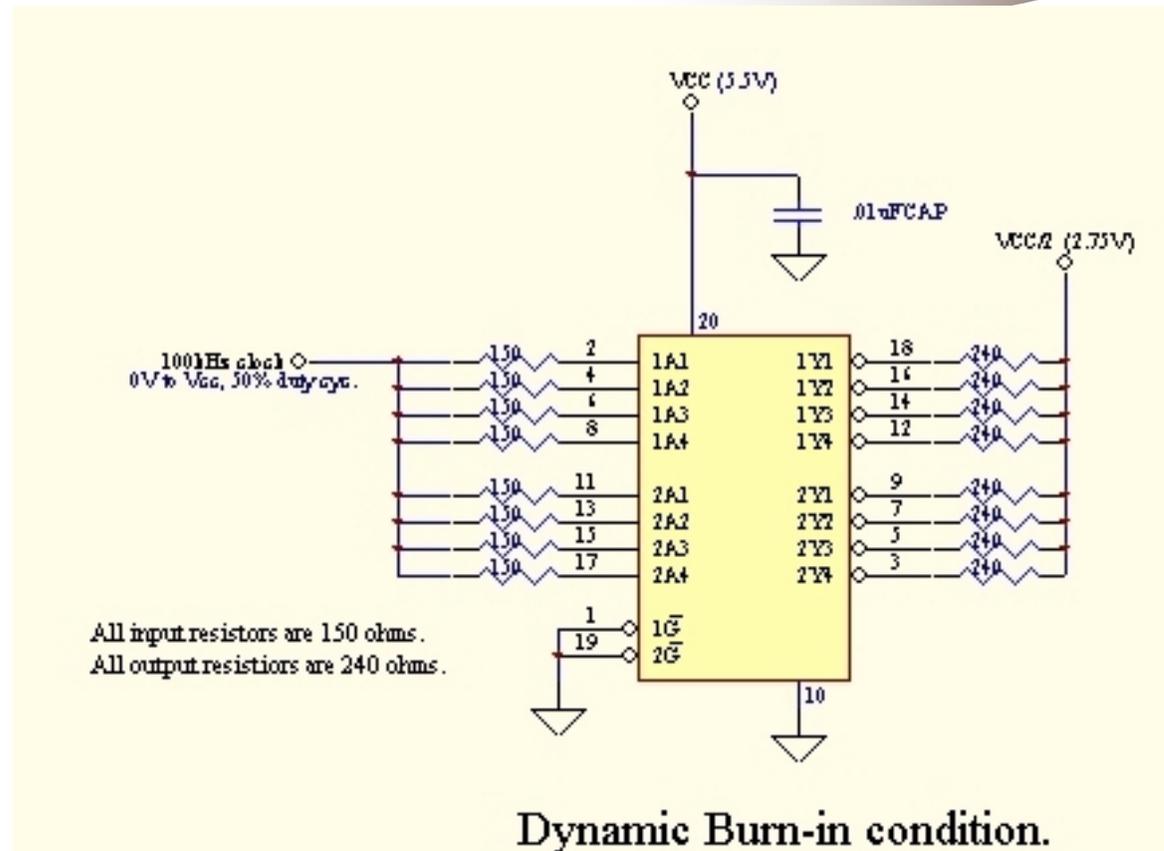
Life Test Circuit

Outputs are
under load
Inputs are not
under load

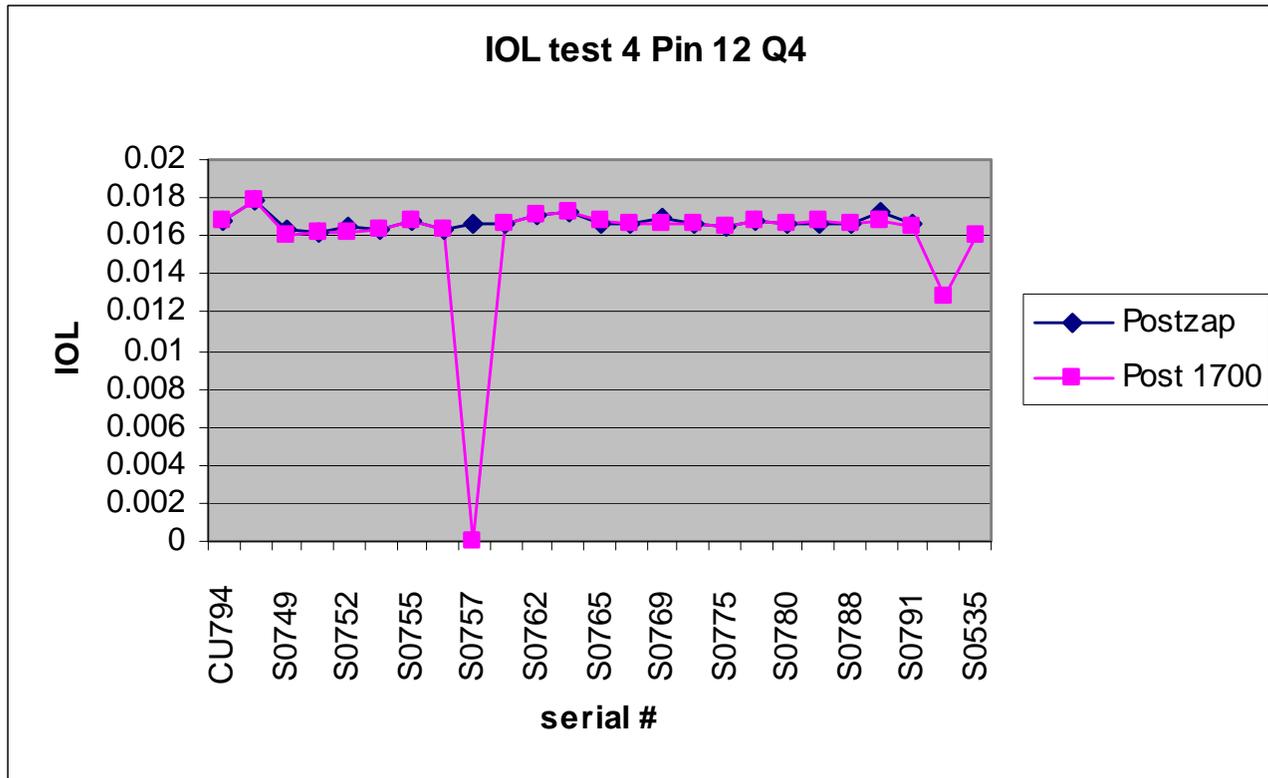
S0757-IOL P12 Q4

Example 1

Output Fails Catastrophic @ <200 hrs Operation

- PreBi = 16.2 ma**
- 168 BI = 16.6 ma**
- Post Zap = 16.6 ma**
- 200 hrs = 0.2 ma**
- 400 hrs = 0 ma**
- 800 hrs = 0 ma**
- 1700 hrs = 0 ma**

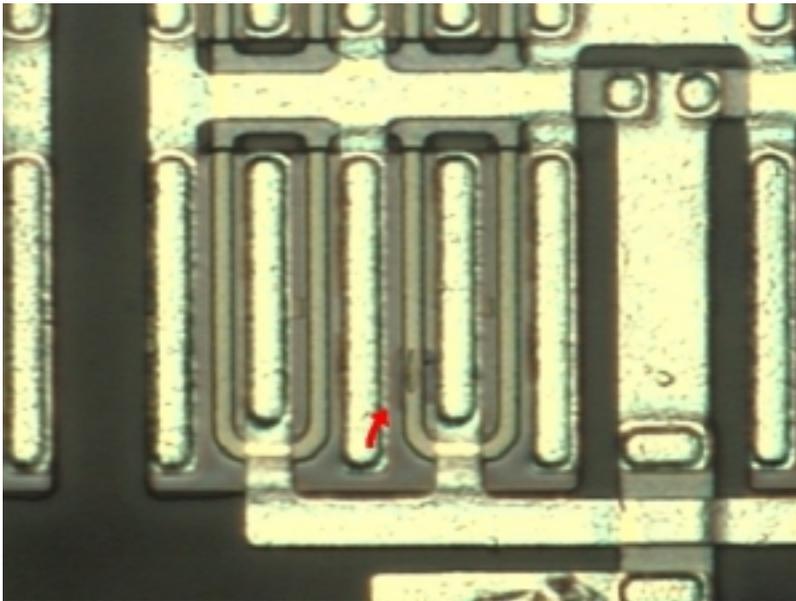
SN769

Source to Drain short
at output enable buffer

Note: Liquid crystal analysis showed that I_{cc} current was flowing in the n-channel

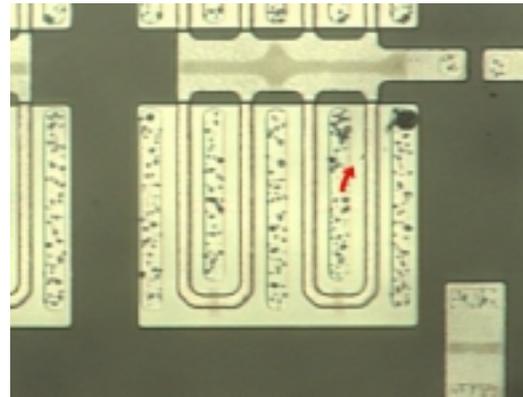
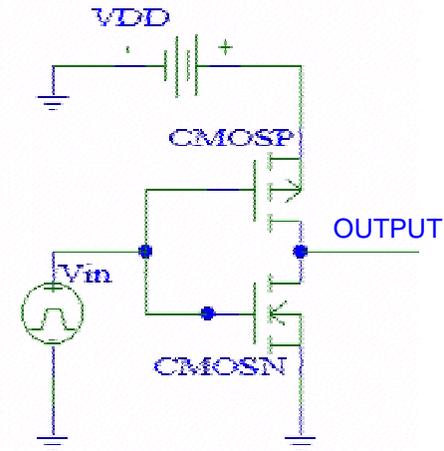
SN749

Source to Drain short
at output enable buffer

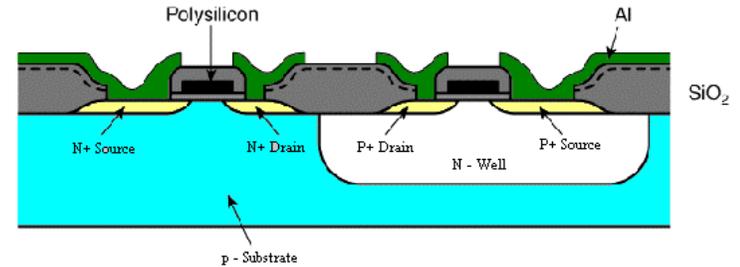
Junction Burnout (short) Model

Junction burnout is caused by injection of an ESD transient of sufficient energy and duration to initiate second breakdown. Subsequent to second breakdown the junction melts or a metal spike can grow from the metallization through the junction. Junction burnout usually results in a high reverse leakage current or a total short.

* $P_j = IV_{BD}$

* $T_j = T_c$

*Resulting in Junction Short

Note with ESD latency it is postulated that the second breakdown is not immediate nor permanent but damage has occurred. Under continue operation and current more energy is dissipated, increasing the temperature until the overstress ends.

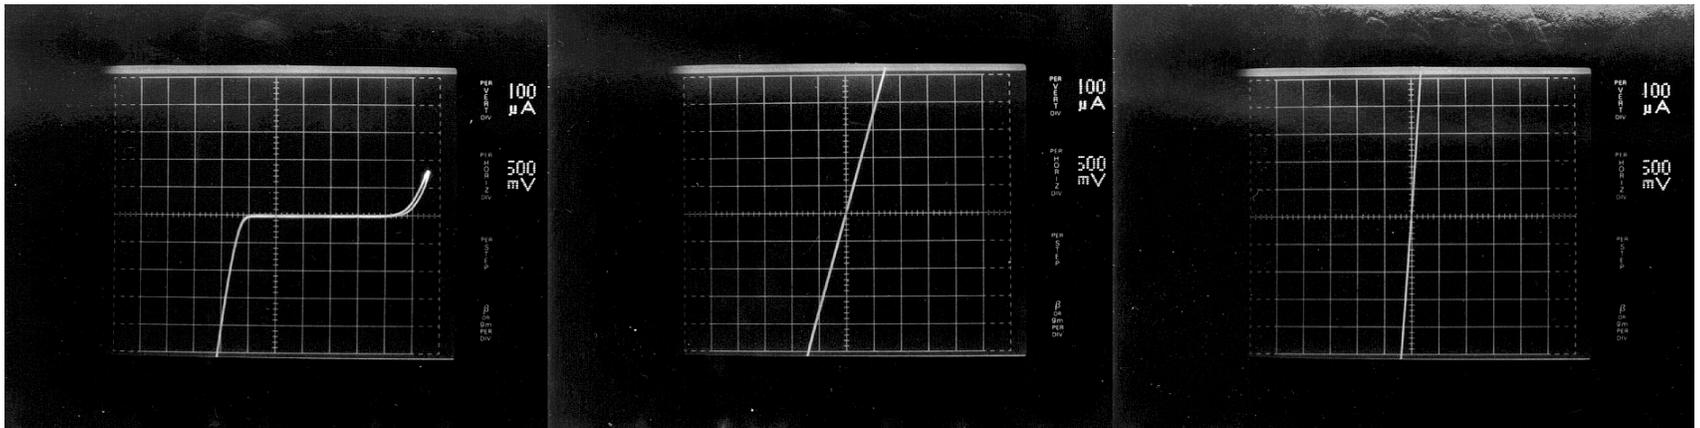
Electrical Signature of Failed Inputs

Curve tracer curves. Photo left is typical of a good input. Photo center is the shorted (2K ohm) S/N S0565 pin-15, and photo right is the shorted (368 ohm) S/N S0568 pin-4.

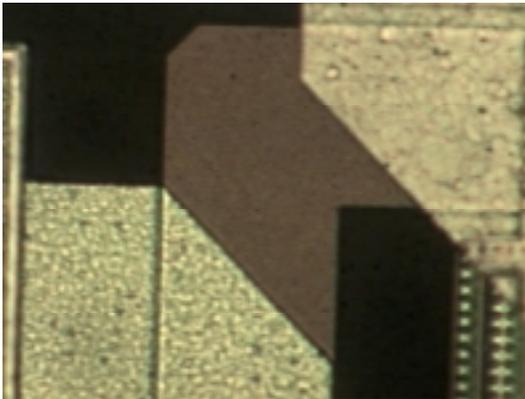
1000V-Not Visible

Input Polysilicon Resistor Damage: Typical failure is short to Vcc & open circuit

ESD input protection resistors used are typically series elements - diffused and or polysilicon

- Diffused resistors can be advantageous because the parasitic diode inherent in the structure dissipates some energy into the substrate
- Polysilicon resistors are electrically isolated from the substrate therefore all of the energy is dissipated in the resistor which can lead to damage in the resistor itself

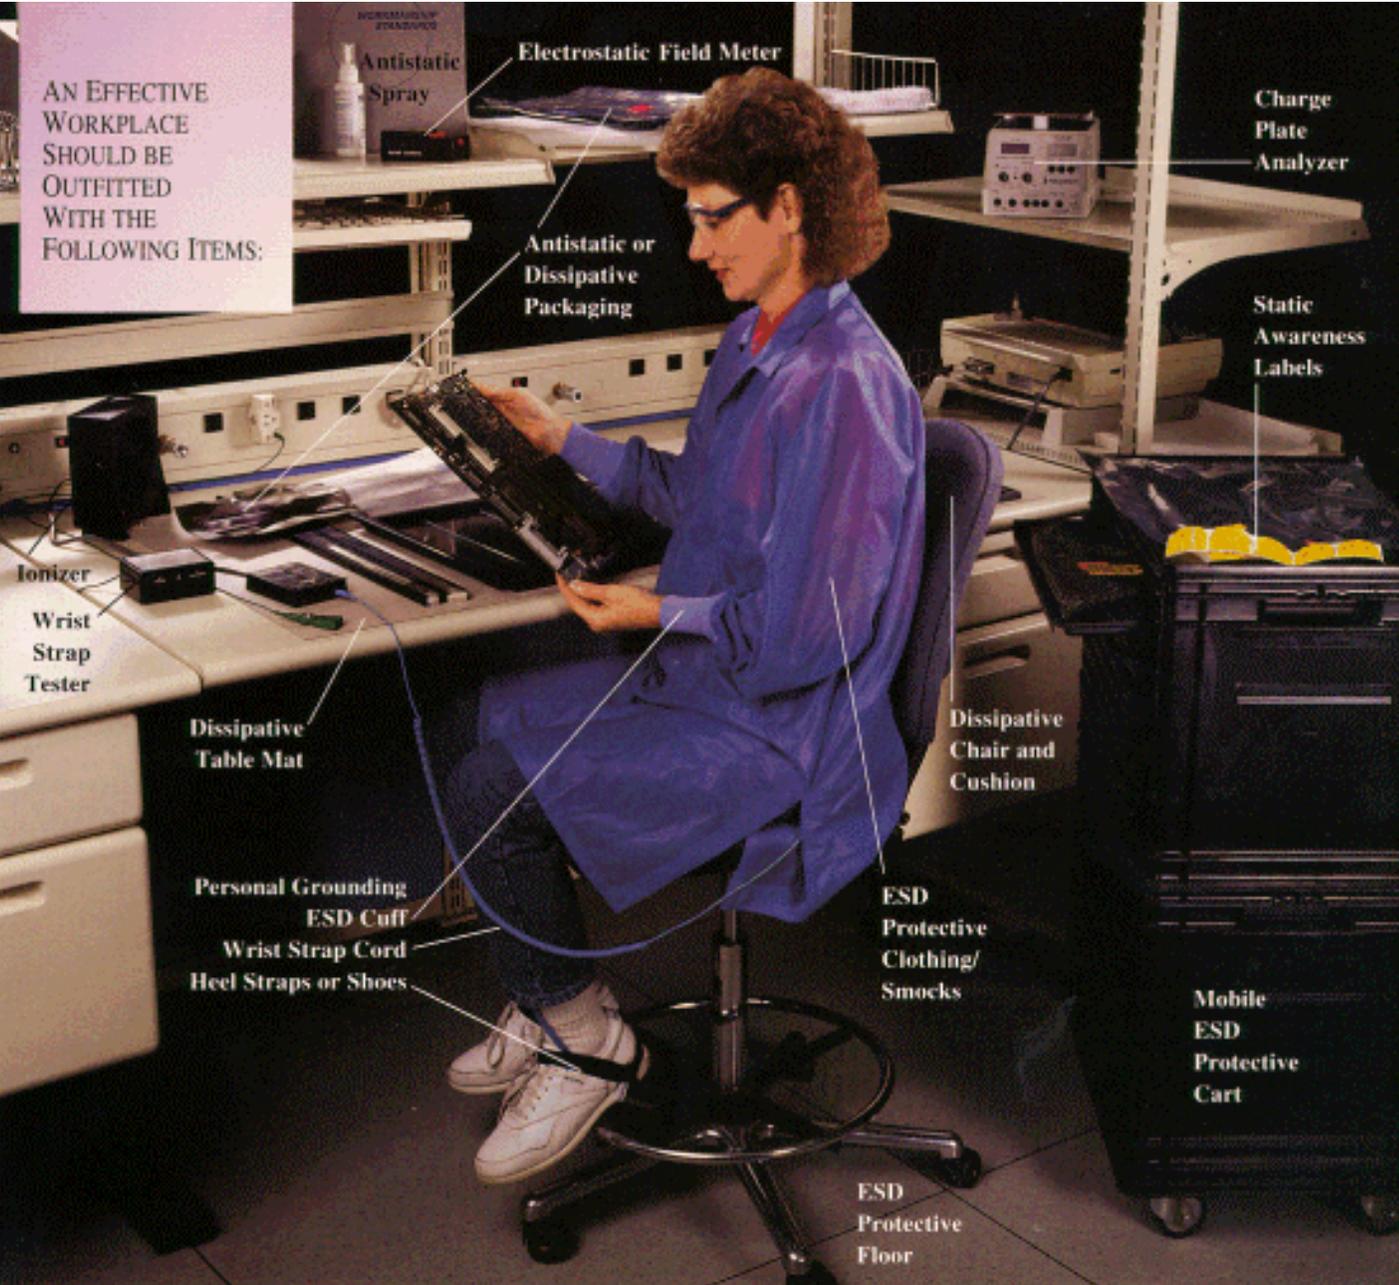
ESD Protected Workstation

Environment/Handling Requirements:

- Wrist Straps
- Anti-static smocks
- Anti-static gloves & finger cots
- Dissipative table tops and mats
- Grounded tip soldering irons
- Grounded stools and chairs
- Anti-static & shielded bags
- Protective tote boxes
- Protective DIP tube & magazines
- Grounded carts
- Humidity control
- Air Ionization
- Voltage suppressors
- Conductive floor tiles
- Shoe grounding straps
- Edge connector shorting bars

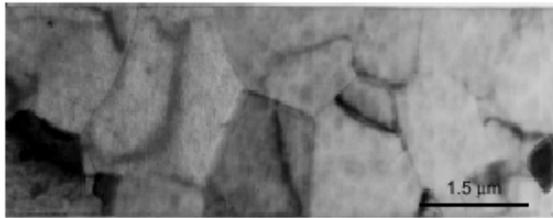
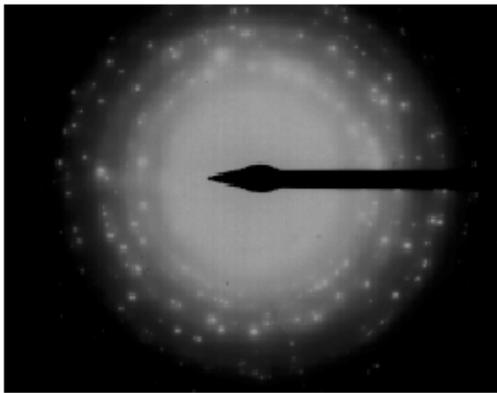
Figure 2. a) TEM micrograph of an unstressed AlCu line with the b) corresponding TEM diffraction pattern. All materials above and below the AlCu line (including the TiN layers) were removed by ion-milling process.

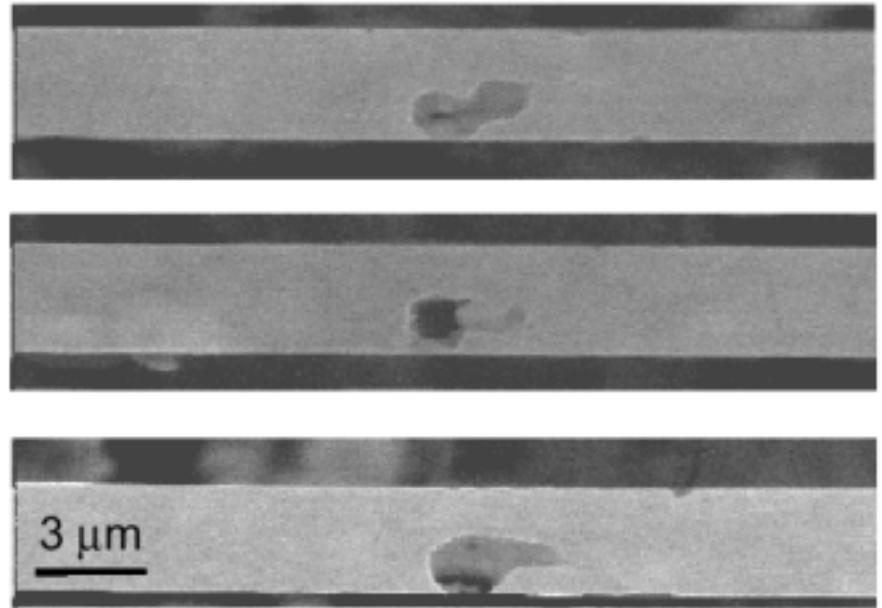
Figure 4. SEM micrographs taken over the white spots showing loss of material or voiding.

The mean EM lifetime was reduced by a factor of 4
